**MAINTENANCE AND FUNCTIONAL RESTORATION OF A  
LABORATORY CENTRIFUGAL PUMP TEST RIG**

**\*Shreyash Samadhan Sonar, Niranjana Anil murtadak, Prof. P. K. Patil Sir**

<sup>1</sup>Student, Mechanical Department, Sandip Foundation's Sandip Polytechnic, Mahiravani,  
Nashik-422313, India.

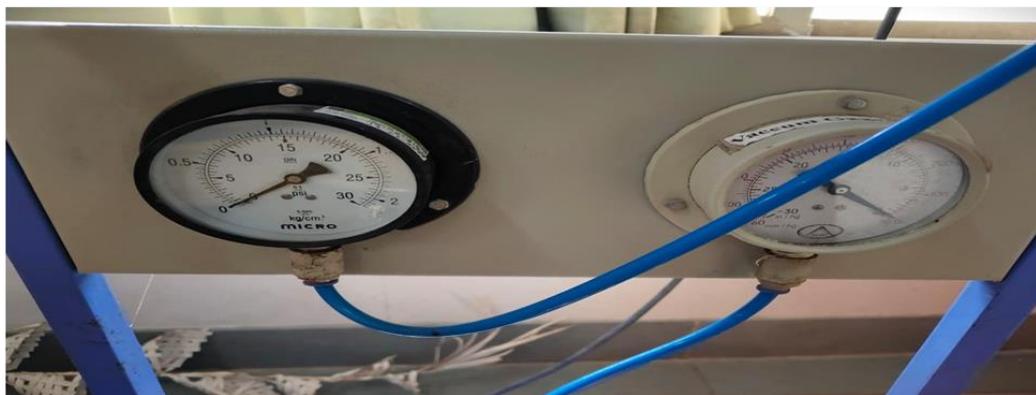
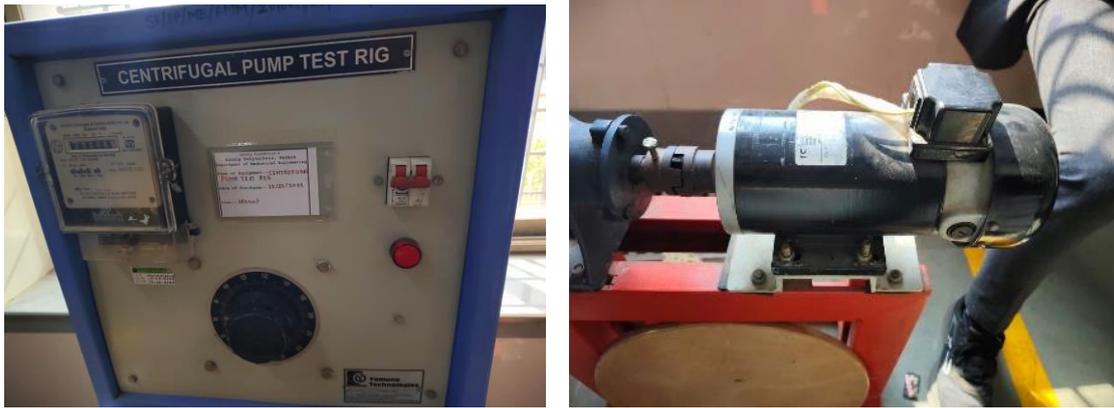
DC motor instability and reduced rotational speed

Leakage in pipeline joints causing discharge loss

Pressure gauge malfunction leading to inaccurate readings

2.2 The faulty DC motor was replaced with a properly rated motor. Alignment was checked to ensure smooth power transmission.

2.4 Damaged pipe sections and loose joints were repaired and sealed to eliminate fluid losses.

The malfunctioning pressure gauge was replaced to ensure accurate head measurement.

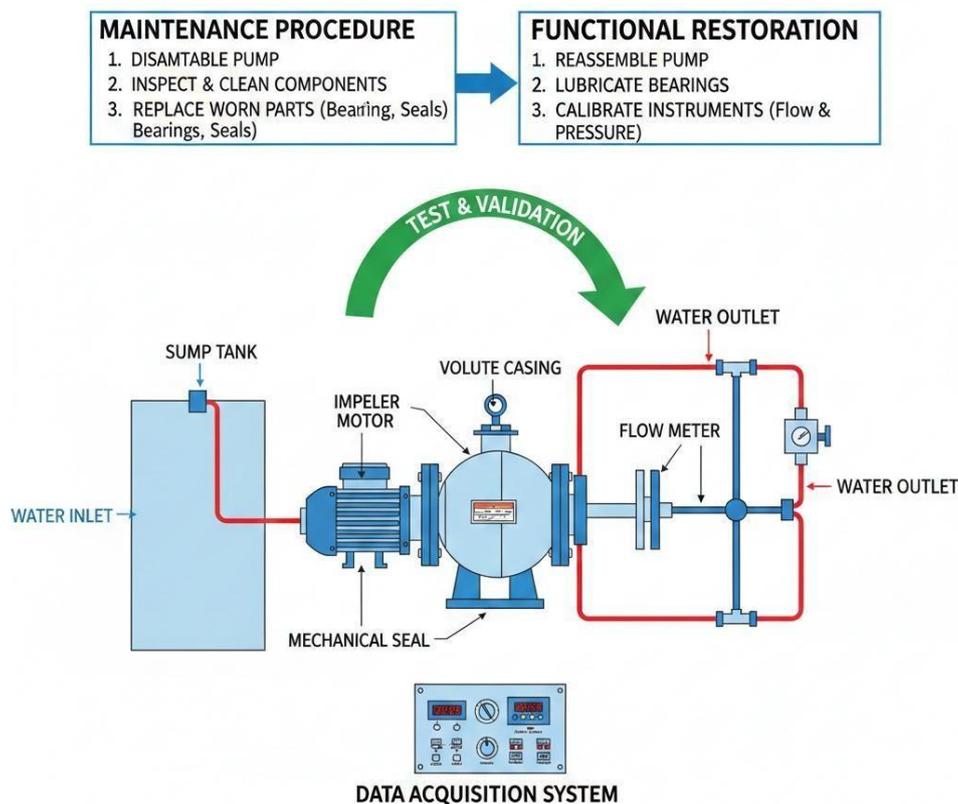
### LABORATORY CENTRUIRAL PUMP TEST RIG: MAINTENANCE & RESTORATION

The apparatus consists of a centrifugal pump coupled to a variable-speed DC motor. The hydraulic circuit includes a suction sump, a delivery tank, a suction pipe with a vacuum gauge, and a delivery pipe equipped with a pressure gauge and a control valve.

1. **Motor Instability:** The DC motor exhibited fluctuations in rotational speed (RPM) and excessive vibration, suggesting internal brush wear or bearing failure.
2. **Hydraulic Integrity:** Significant fluid leakage was observed at the delivery flange joints, leading to a discrepancy between the pumped volume and the measured discharge.
3. **Instrumentation Error:** The Bourdon tube pressure gauge on the delivery side showed non-zero readings at rest (zero error) and sluggish response during operation.

- **DC Motor Replacement:** The faulty motor was replaced with a new 1 HP DC shunt motor. A critical step involved the precise alignment of the motor shaft with the pump shaft using a dial gauge indicator to minimize vibration and transmission losses.
- **Leakage Rectification:** The piping system was dismantled at the fault points. Old gaskets were scraped off and replaced with high-grade rubber gaskets and Teflon sealing tape. The flange bolts were tightened in a star pattern to ensure uniform compression and a hermetic seal.
- **Instrumentation Overhaul:** The defective pressure gauge was replaced with a calibrated gauge (Range: 0–4 bar). The suction vacuum gauge was recalibrated using a dead-weight tester to ensure accuracy.

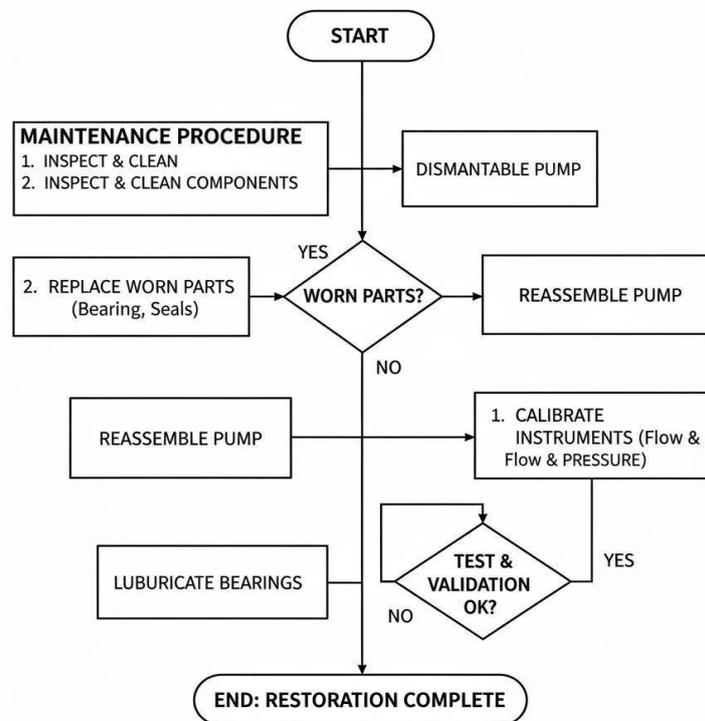
$Q$  was varied using the delivery valve, and readings were taken at seven distinct operating points. Flow chart :-

The restoration methodology was executed in a structured three-phase framework: Fault Isolation, Corrective Action, and Experimental Validation.
